# Manhole Inspection Summary

Manhole # S29YY\_026MH

Insp Date: **5/23/07 10:13 AM**

**Location** Address: **3334 BEECH AVE**

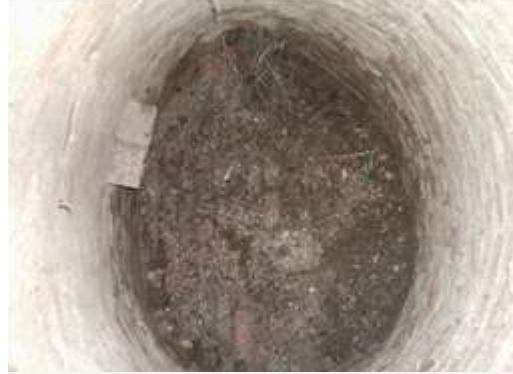
Top View

Channel debris. Barrel root intrusion and infiltration.

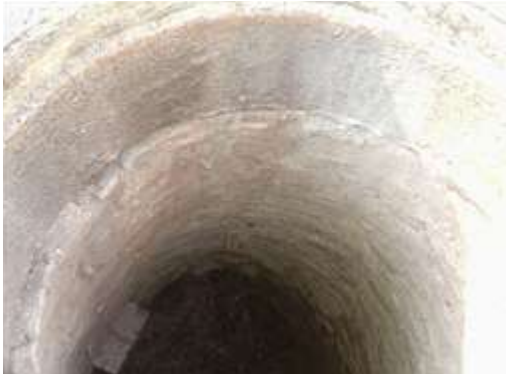
Defect

Frame leaks. Adjustment and Barrel infiltration.

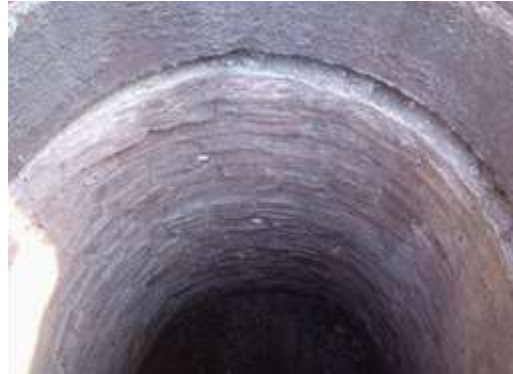
Defect

Frame leaks. Adjustment infiltration.

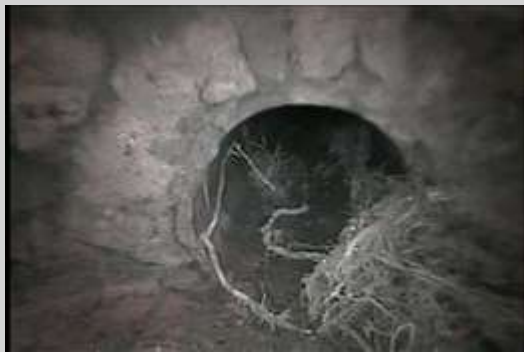
8 in. Circular Gravity Sewer  
Pipe Out @ 12 O'Clock

Infiltration: **Evidence** Pipe Seal Cond: **Cracked**
